CWA COMPLIANCE EVALUATION INSPECTION REPORT
U.S. ENVIRONMENTAL PROTECTION AGENCY, REGION 5

Purpose:
Compliance Evaluation Sampling Inspection

Ex. 6 (Personal Privacy) Farms

Date of Inspection:
November 6, 2013

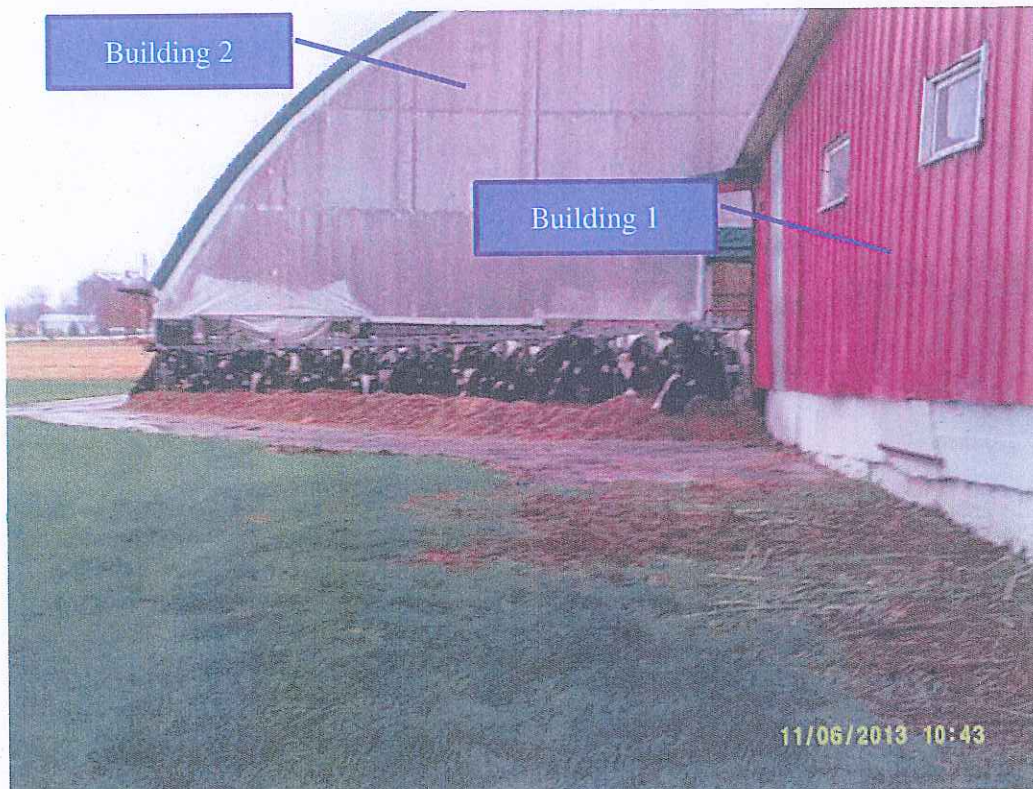
Photo DSCF004: Cows being fed between Building 1 and Building 2
Date/Time: 11/6/2013 10:43 A.M Location: East Side of Building 1. Facing: South

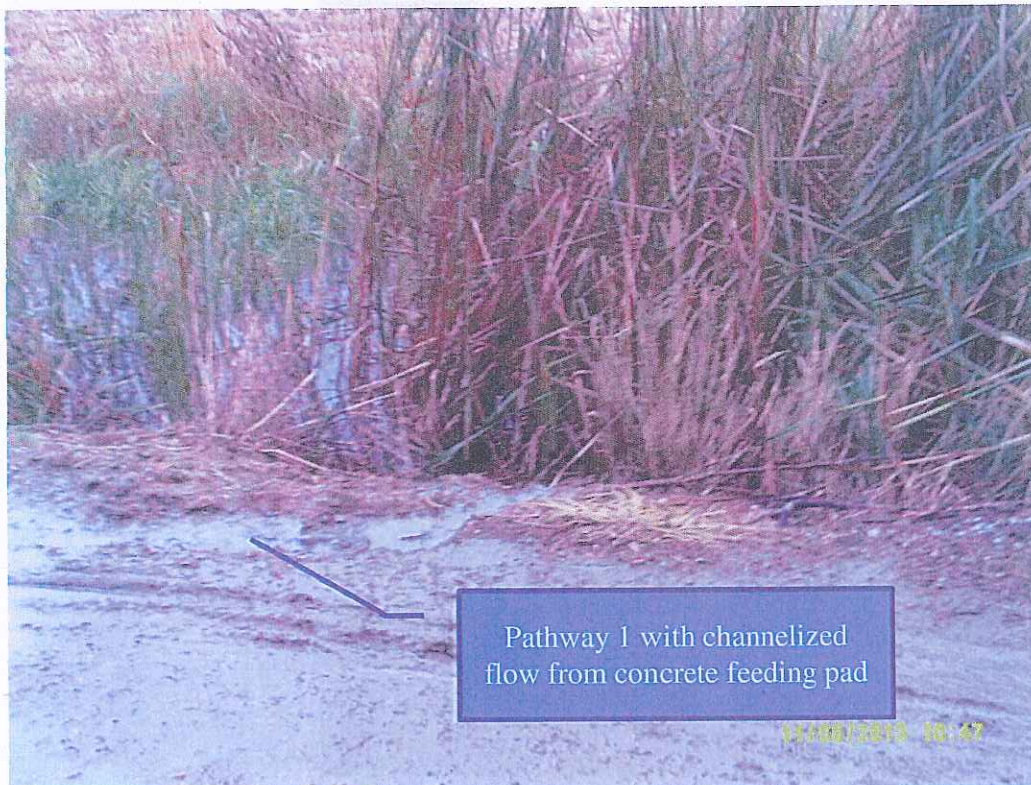
The inspectors observed a concrete pad along the east side of Building 2 used to feed the animals confined in Building 2. The pad was generally clean on the day of the inspection and the feed was mostly under the overhang of Building 2. EPA observed some precipitation falling on the concrete pad mingling with the feed on the pad resulting in runoff flowing to the unnamed tributary. The flow of potentially contaminated runoff from the concrete pad flowed across the south access road and formed a slight channel as it flowed into the unnamed tributary (pathway 1).

Photo DSCF008: Flow from concrete pad on east side of Building 2, flowing into unnamed tributary.
 Date/Time: 11/6/2013 10:47 A.M. Location: Southeast corner of Building 2. Facing: South

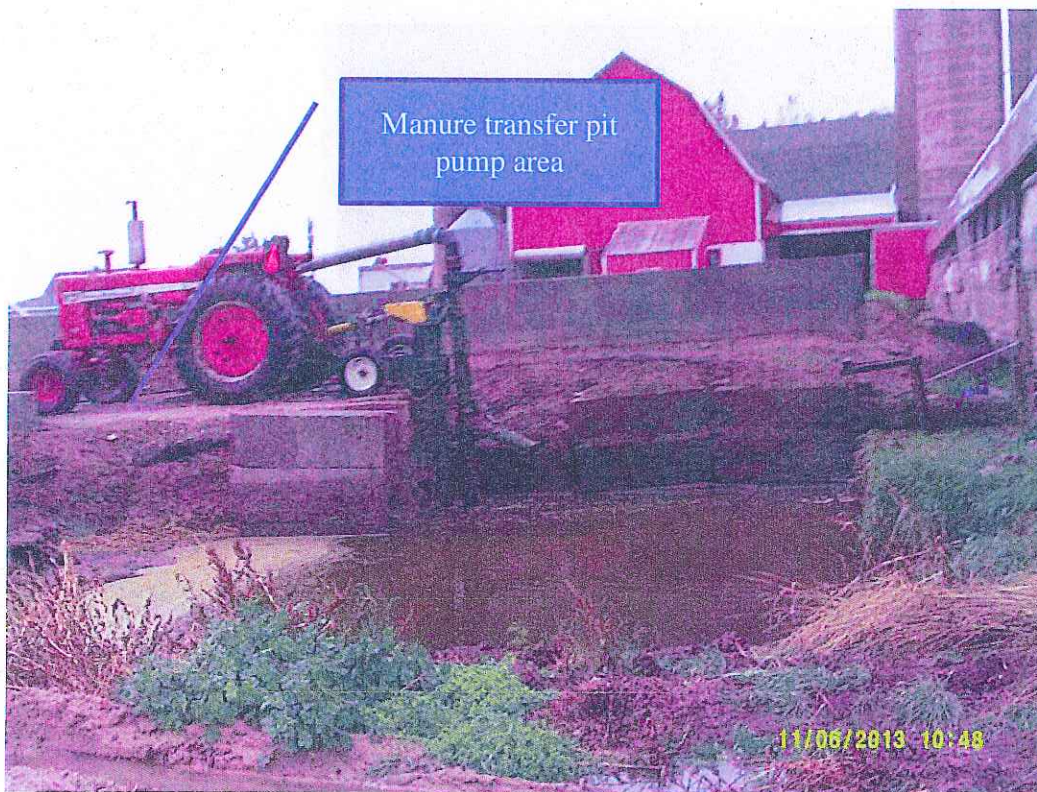
PhotoDSCF009: Manure transfer pit and top of manure storage pit in background.
 Date/Time: 11/6/2013 10:48 A.M. Location: Southwest corner of Building 2 Facing: North

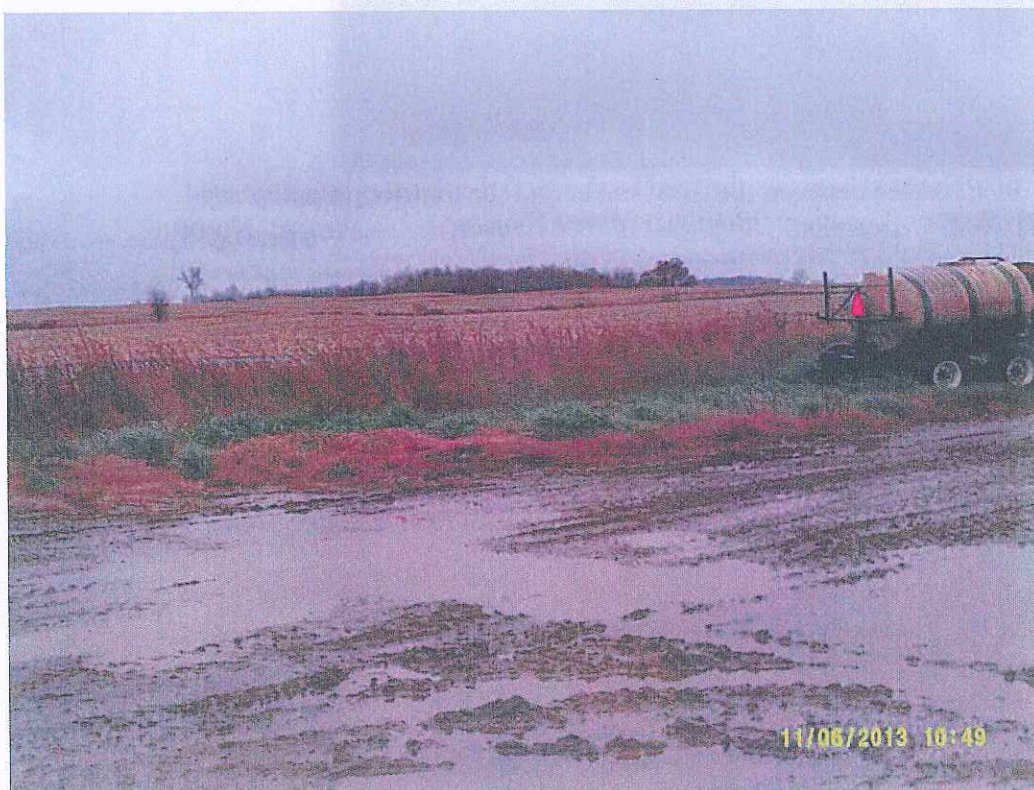
The inspection proceeded west on the south side of Building 2. EPA observed the manure transfer pit into which manure is pushed from Building 2. At the time of inspection, a tractor was hooked to a pump in the transfer pit. This pump, when active, pumps manure from the transfer pit to the manure storage pit. The back side of the manure storage pit was visible immediately north of the transfer pit. Precipitation runoff from the transfer pit pump area where the tractor was parked and surrounding access road was noted flowing south across the south access road toward the unnamed tributary.

Photo: DSCF0012 – Precipitation runoff from manure transfer pit pump area and access road flowing on south access road toward unnamed tributary
 Date/time: 11/6/2013 10:49 A.M. Location: Southwest corner of Building 2 Facing: Southwest

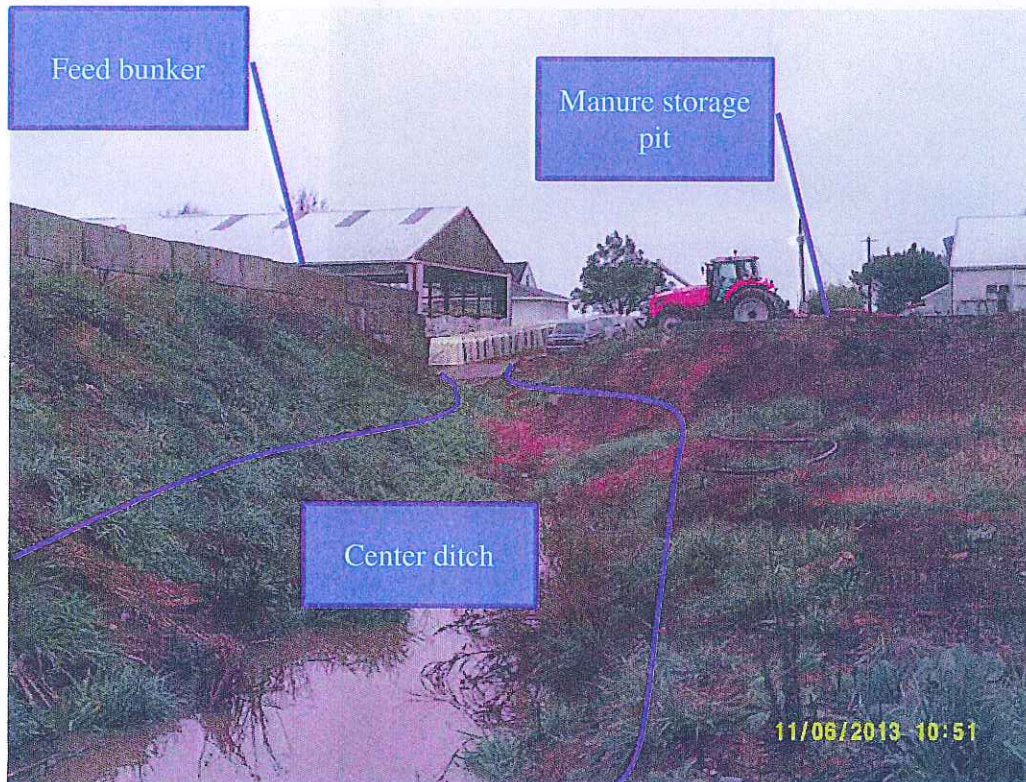
The inspectors noted a ditch between the feed bunker and the transfer pit pump area where the tractor was parked (center ditch). The center ditch connected to the unnamed tributary through a culvert that ran beneath the south access road (south access road culvert). The water level in the unnamed tributary was high enough that it had backed up through the south access road culvert into the center ditch. There was also a culvert in line with the unnamed intermittent tributary which allowed the unnamed intermittent tributary to flow beneath the County Road T access road (County Road T access road culvert). The inspectors checked for and noted flowing water in the unnamed tributary and through the County Road T access road culvert.

Photo: DSCF0013: Center ditch located between the feed bunker and the transfer pit pump area.
Date/Time: 11/6/2013 10:51 A.M. Location: Southeast of feed bunker. Facing: North

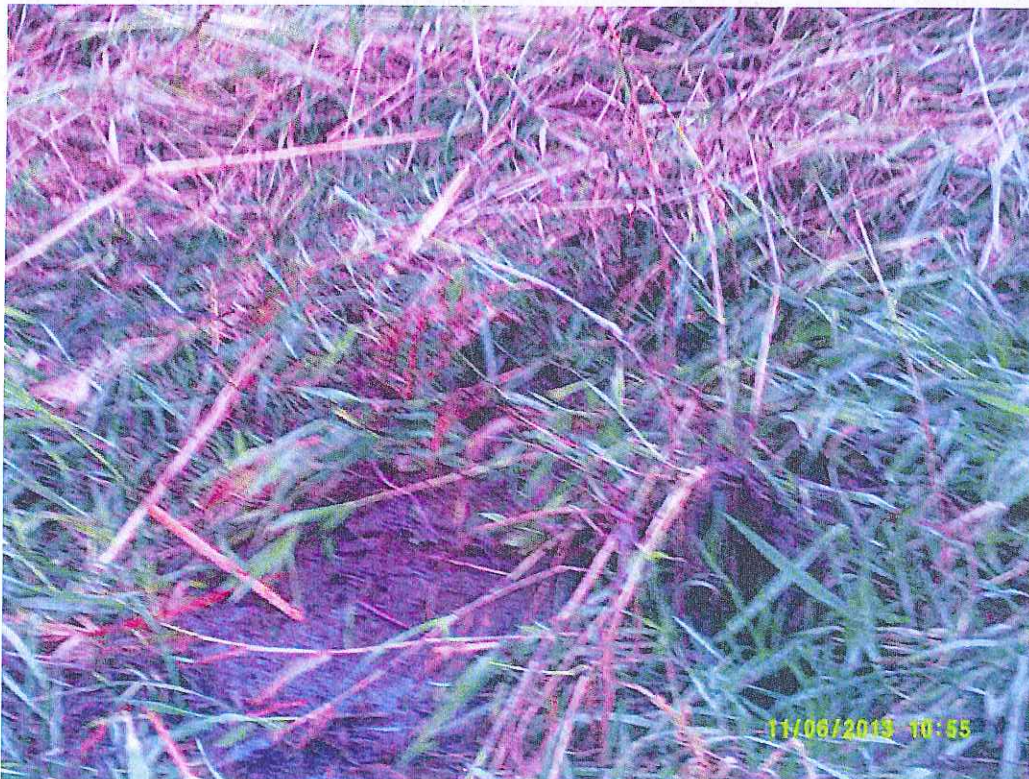
The Inspectors continued west along the south side of the facility. The inspectors noted the flow of water in the unnamed intermittent tributary. There was what appeared to be a black residue on the vegetation and ground along the edge of the unnamed intermittent tributary. The slope of the ground and flow of surface water around the facility is towards the unnamed intermittent tributary

DSCF0020: Black residue on the ground and vegetation along the unnamed intermittent tributary.
 Date/Time: 11/6/2013 10:55 A.M. Location: South of feed bunker. Facing: South

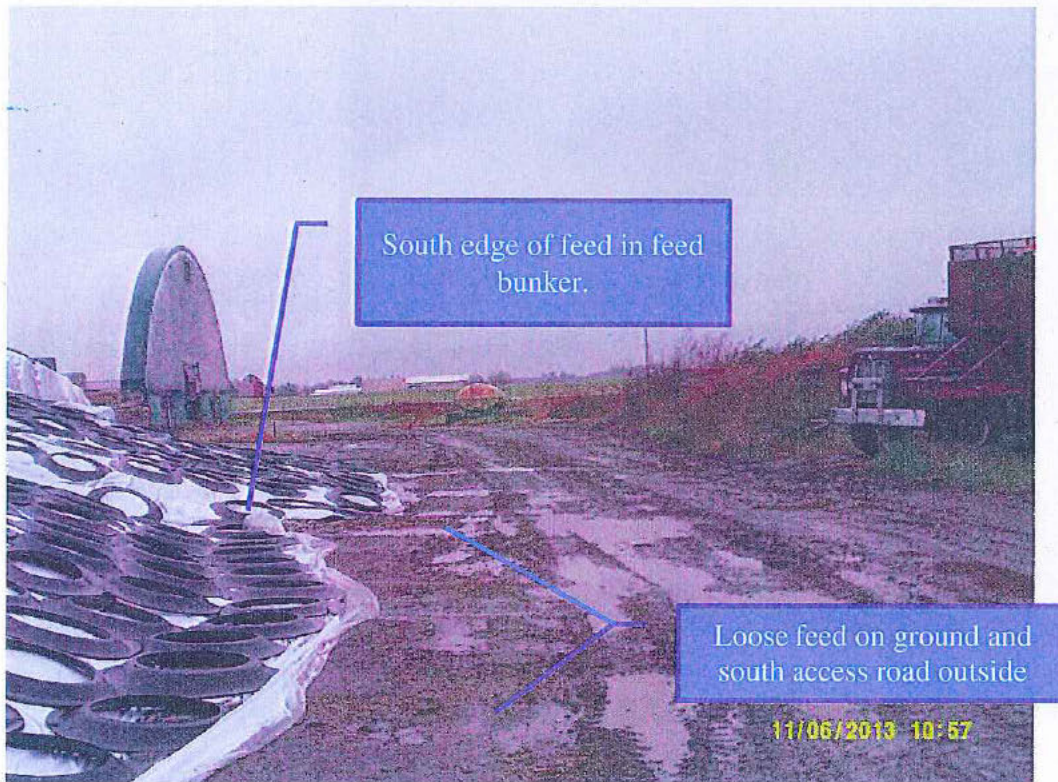
The Inspectors continued west along the south side of the facility. It was noted that the feed in the feed bunker extended beyond the edge of the feed bunker. Loose feed was also seen beyond the edge of the plastic covering the feed in the bunker. Precipitation and surface runoff were mingling with this loose feed.

Photo: DCSF0023: South edge of feed bunker.

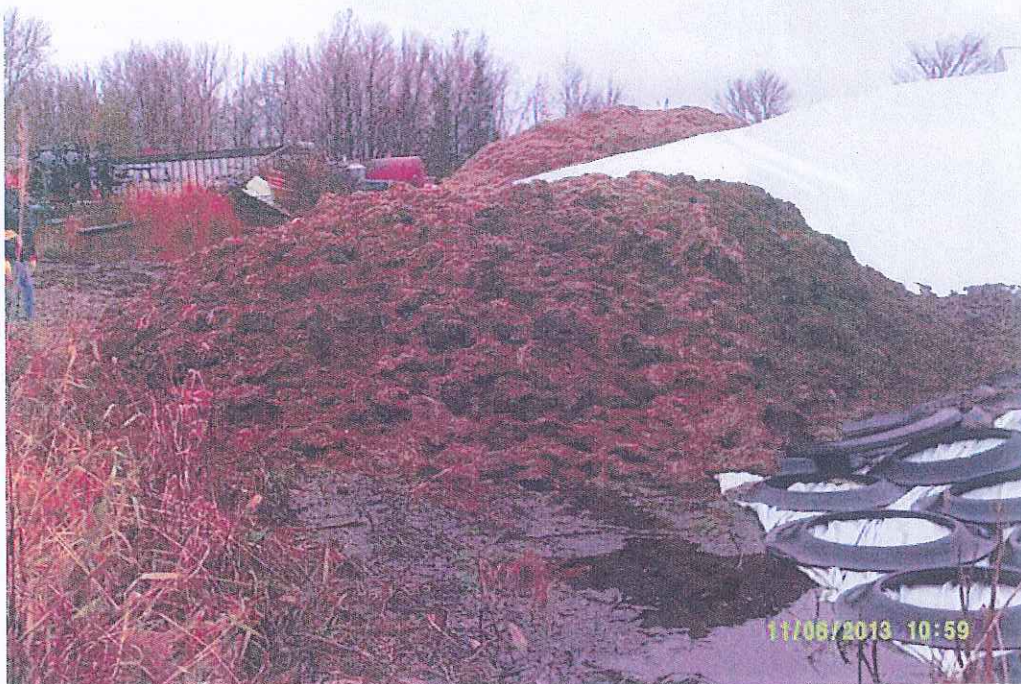
The inspectors continued around the southern edge of the facility. Three white plastic covered mounds of feed were located west of the feed bunker. Two additional piles of non-covered feed were also present west of the feed bunker. Ex. 6 (Personal Privacy) stated that the non-covered feed piles were haylage. Dark colored leachate, surface runoff, and feed debris from the non-covered feed piles, the base of the covered feed mounds, and spilled loose feed were observed. In addition to the surface runoff flowing directly into the unnamed intermittent tributary the inspectors found two channels through which the leachate, surface runoff, and feed debris were flowing to the unnamed intermittent tributary. The first of these channels was located west between covered feed mounds 1 and 2 (pathway 2). Pathway 2 is the sampling location for sample S02.

Photo DSCF0024: Darkly colored leachate and runoff surrounding the base of covered feed mound 1 and non-covered feed mound 1.

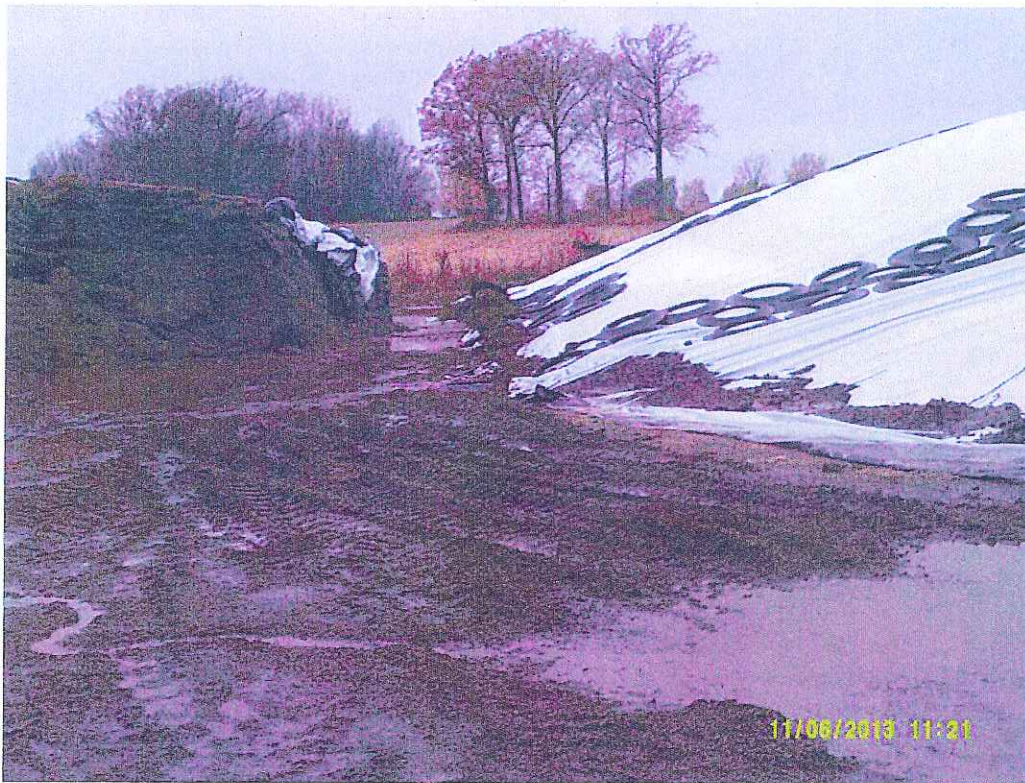
DSCF0052: Surface runoff mixing with loose feed and leachate and flowing between covered feed mounds 1 and 2 to pathway 2.

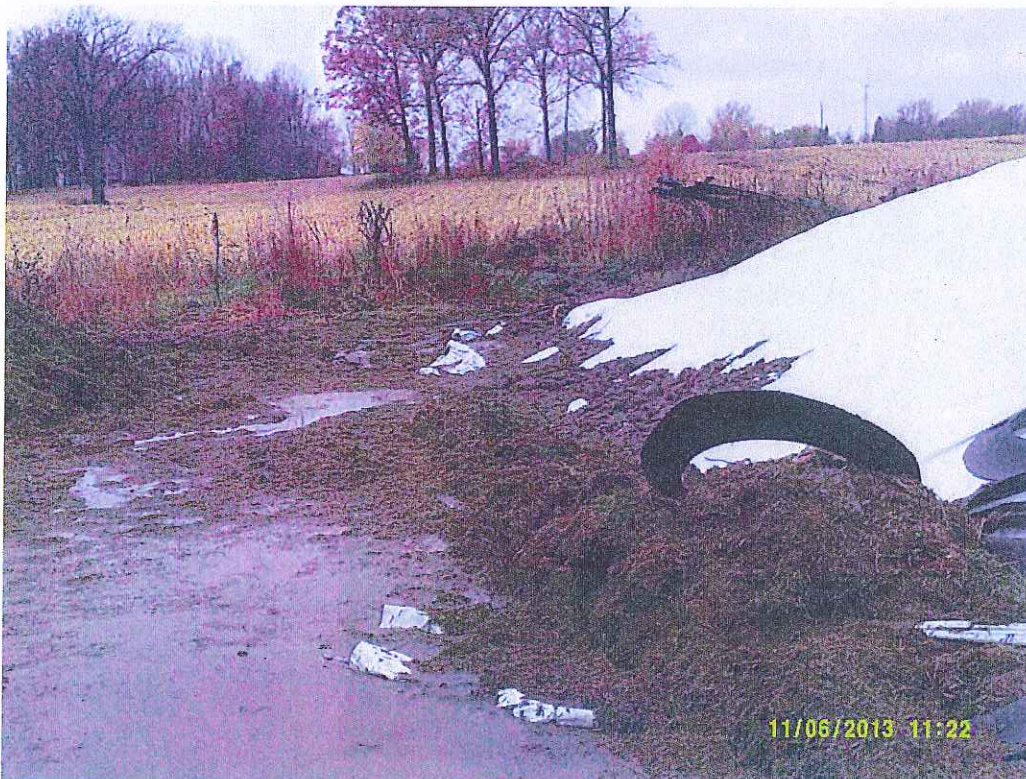
Photo DSCF0054: Surface runoff mixing with loose feed and leachate and flowing between covered feed mounds 1 and 2 to pathway 2.

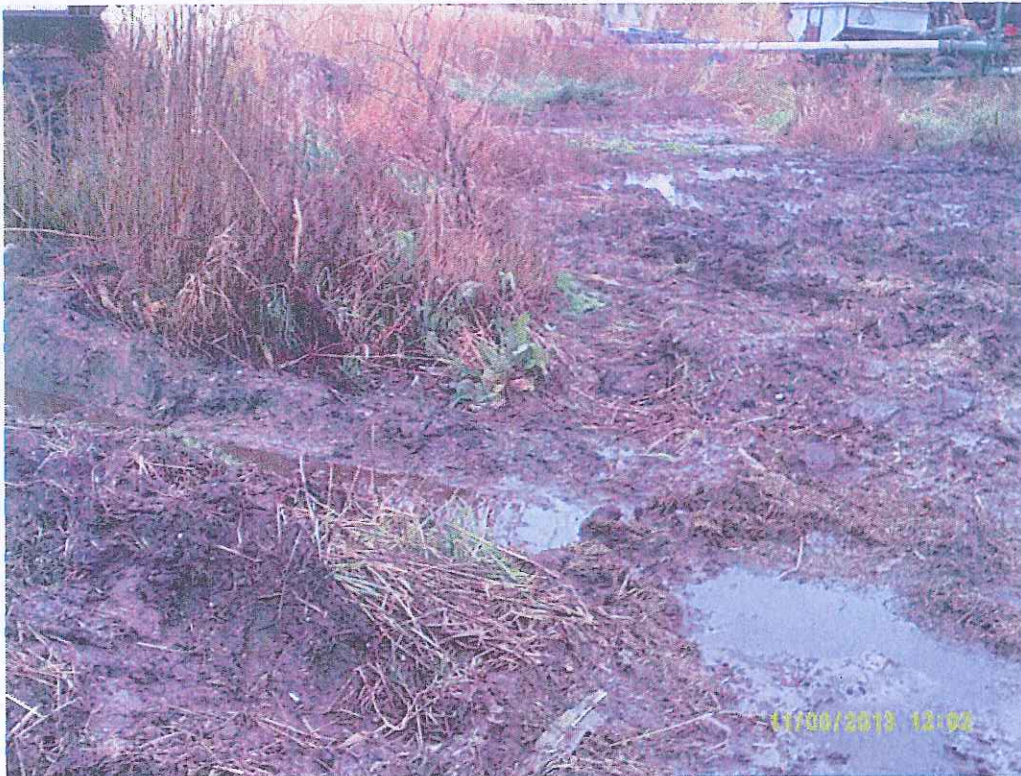
Photo DSCF0069: Flow of runoff through pathway 2 to unnamed intermittent tributary.
 Date/Time: 11/6/2013 12:02 P.M. Location: West side of facility between covered feed mounds 1 and 2.
 Facing: Northwest

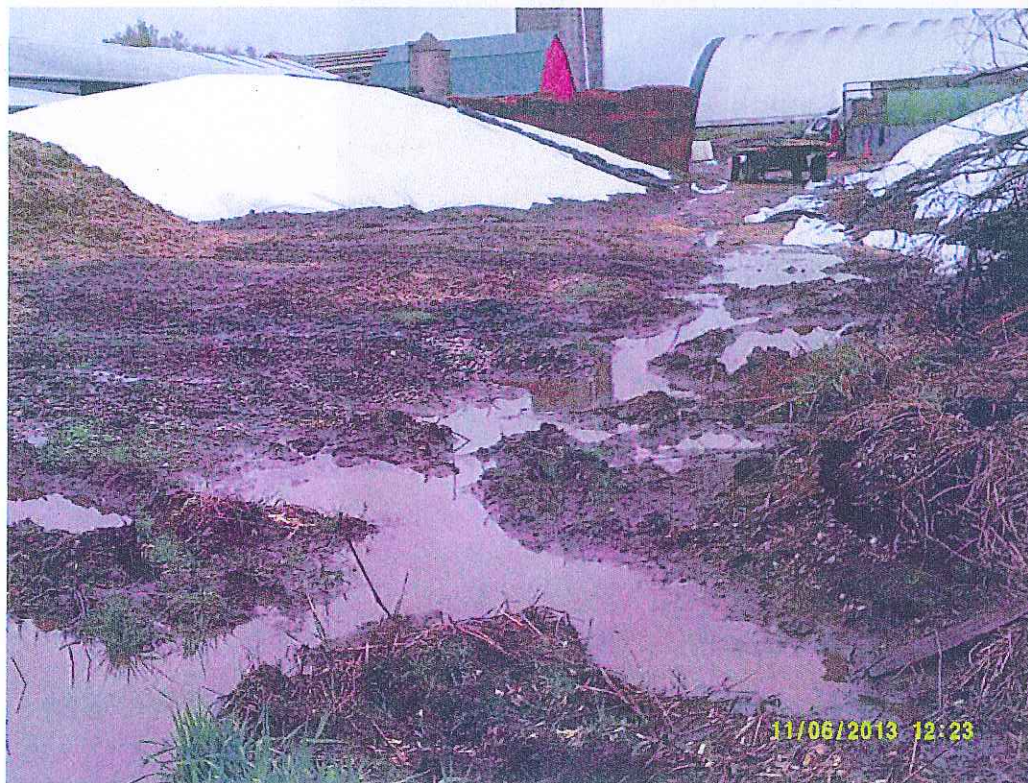
The second channel was located west between covered feed mounds 2 and 3 (pathway 3). Pathway 3 was also observed to be transporting leachate, surface runoff, and feed debris from between covered feed mounds 2 and 3 and surrounding areas to the unnamed intermittent tributary. Pathway 3 is sampling location for sample S03.

Photo DSCF0078: Pathway 3 conveying runoff, leachate, and feed debris to unnamed intermittent tributary.
Date/Time: 11/6/2013 12:23 P.M. Location: West side of facility between covered feed mound 2 and 3.
Facing: Northeast

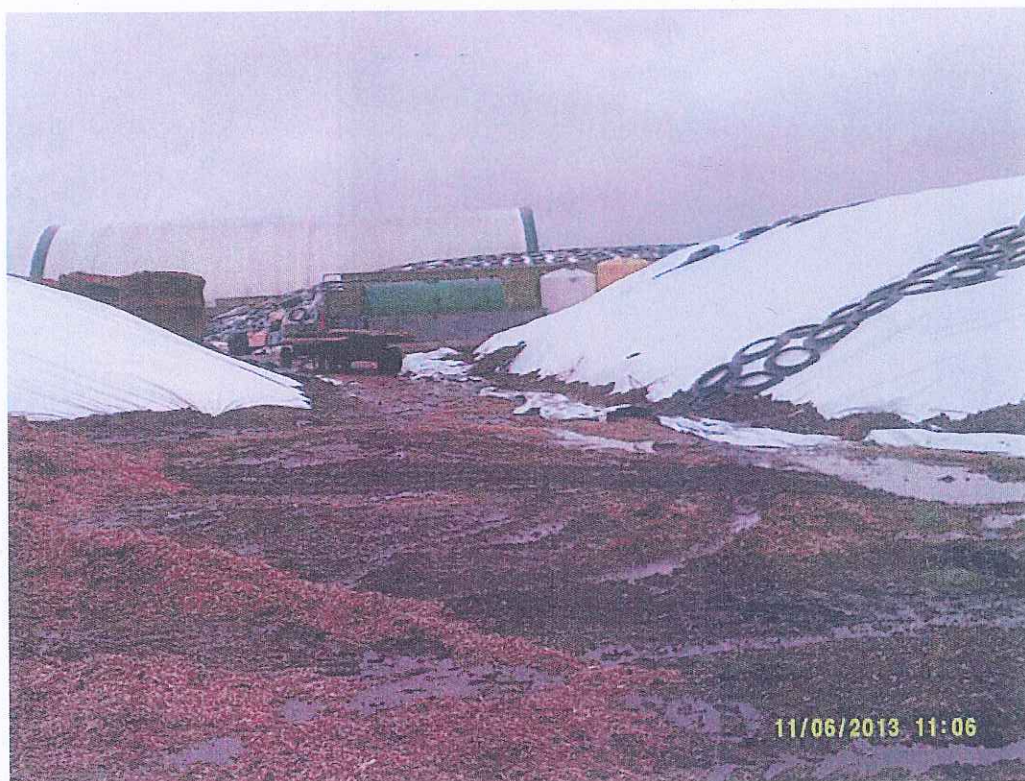
Photo DSCF0034: Surface runoff loose feed and leachate and flowing between covered feed mounds 2 and 3 to pathway 3.

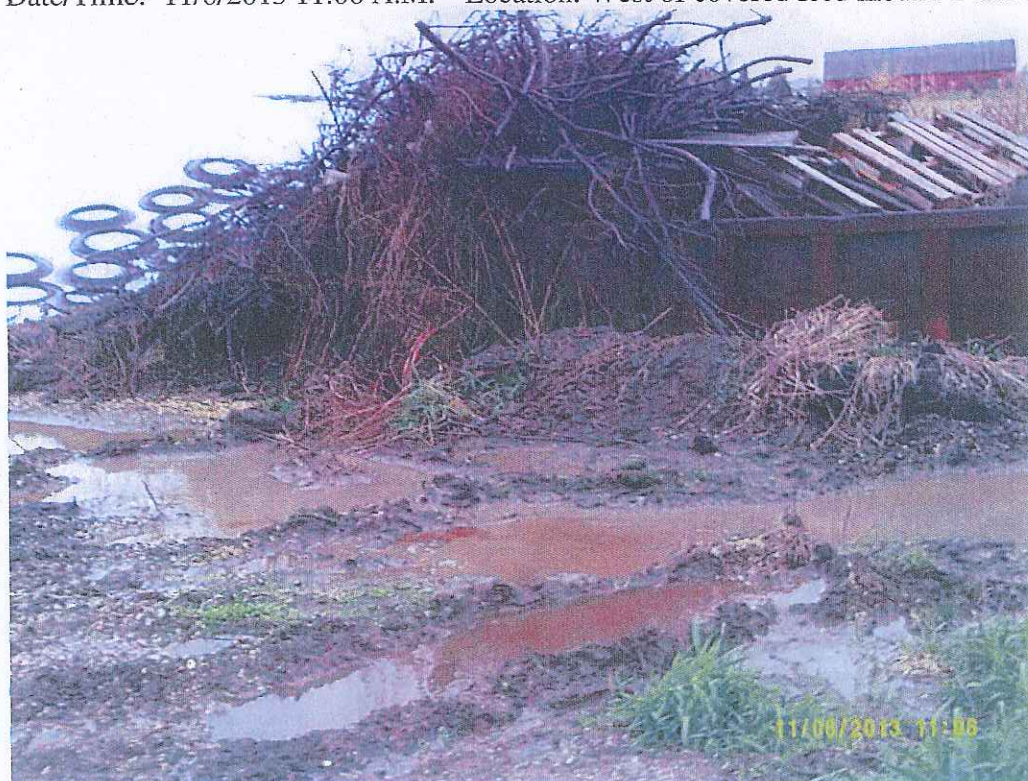
DSCF0032: Surface runoff mixing with loose feed and leachate and flowing between covered feed mounds 2 and 3 to pathway 3.

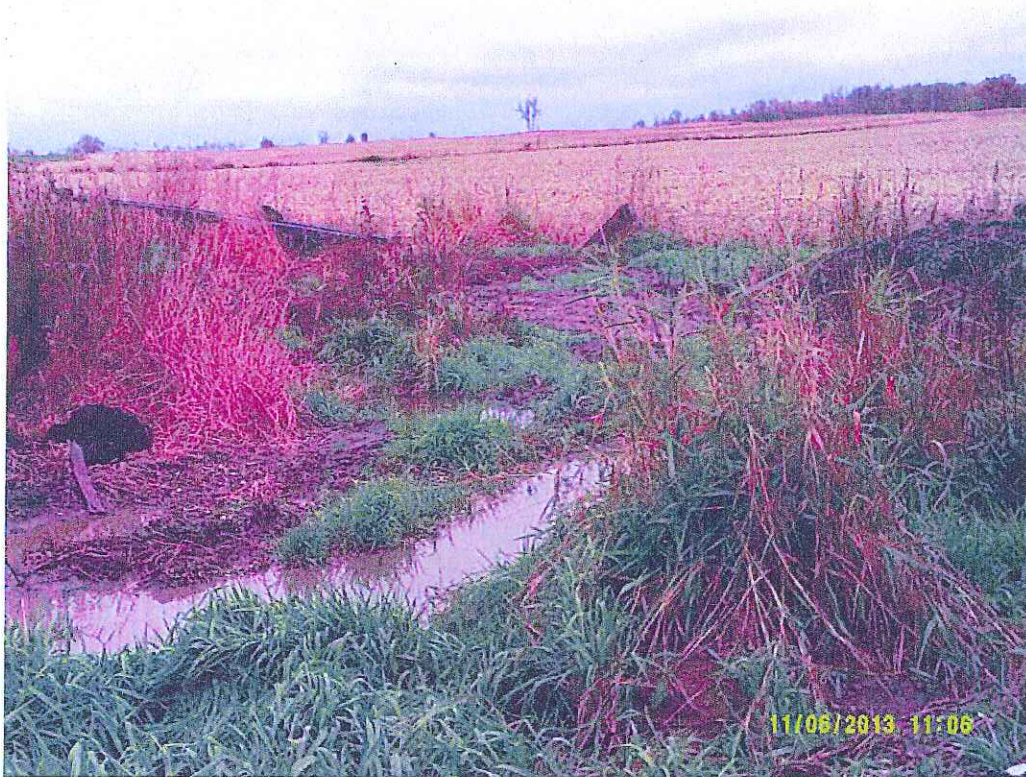
Photo DSCF0033: Pathway 3 conveying runoff, leachate, and feed debris to unnamed intermittent tributary.
 Date/Time: 11/6/2013 11:06 A.M. Location: West side of facility between covered feed mound 2 and 3.
 Facing: Southwest

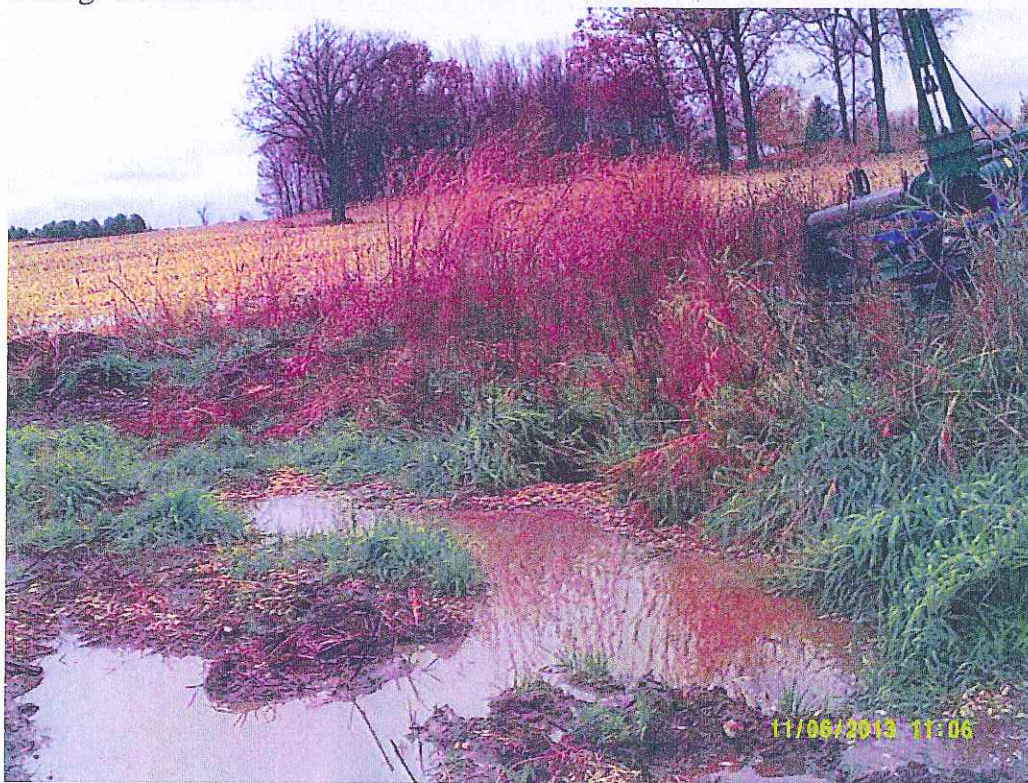
Photo DSCF0035: Pathway 3 conveying runoff, leachate, and feed debris to unnamed intermittent tributary.
 Date/Time: 11/6/2013 11:06 A.M. Location: West side of facility between covered feed mound 2 and 3.
 Facing: West

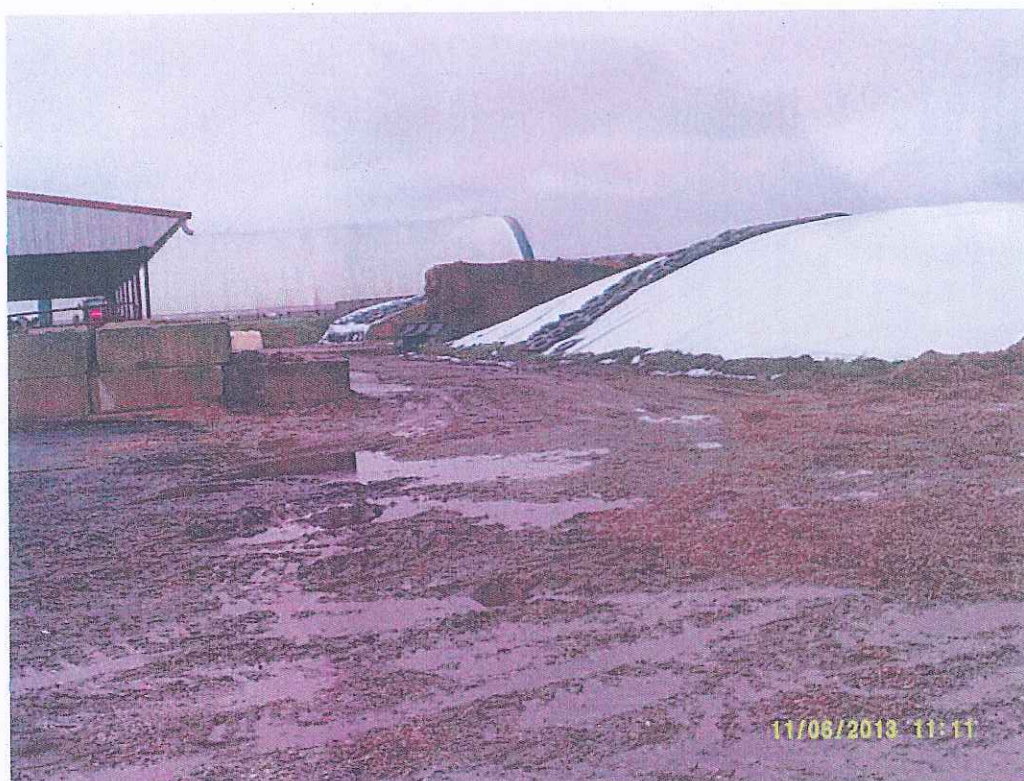
The inspectors continued walking along the west side of the facility. Surface runoff from the north access road was seen to be flowing west and mixing with leachate and feed debris from covered feed mound 3, non-covered feed mound 2, and loose feed on the ground. This runoff flowed west around parked trucks and machinery towards the unnamed intermittent tributary.

Photo DSCF0037: Surface runoff flowing west through loose feed and leachate toward unnamed intermittent tributary.

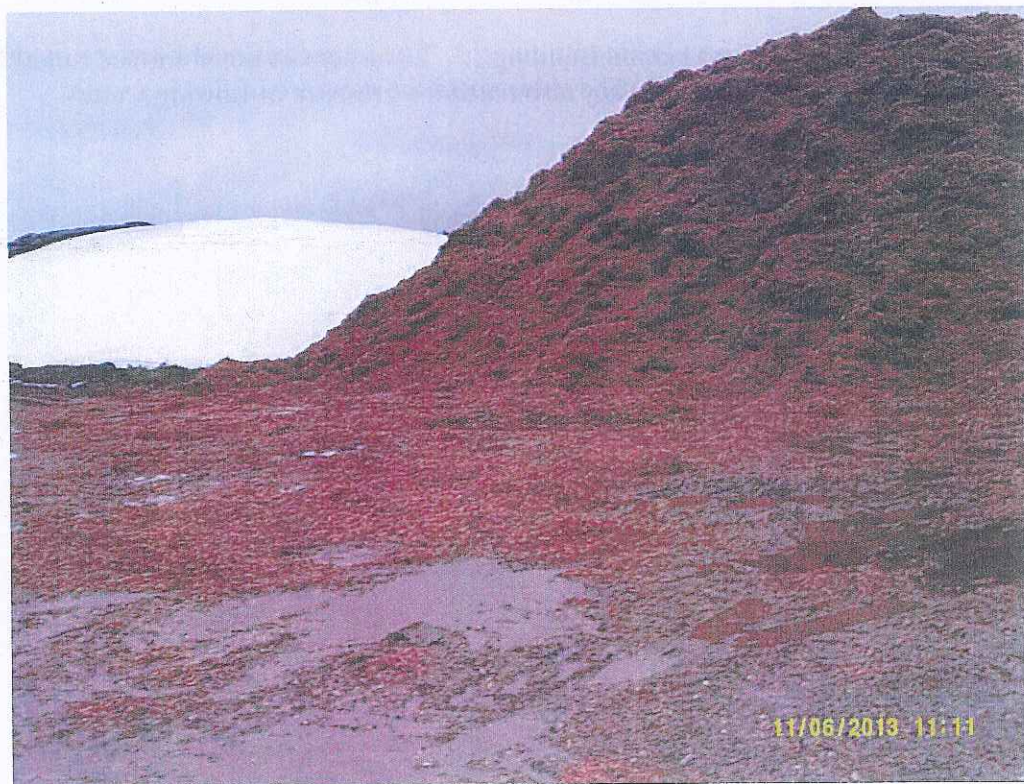
Photo DSCF0038: Surface runoff flowing west through loose feed and leachate toward unnamed intermittent tributary.

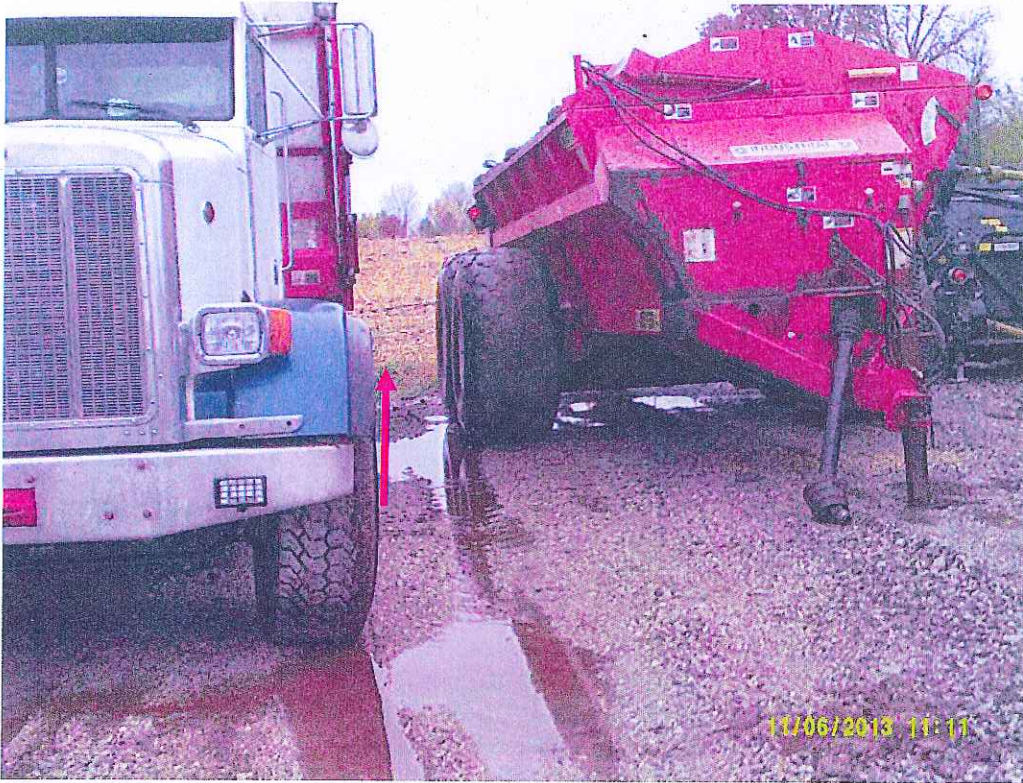
Photo DSCF0039: Surface runoff flowing west around parked trucks/machinery toward unnamed intermittent tributary.

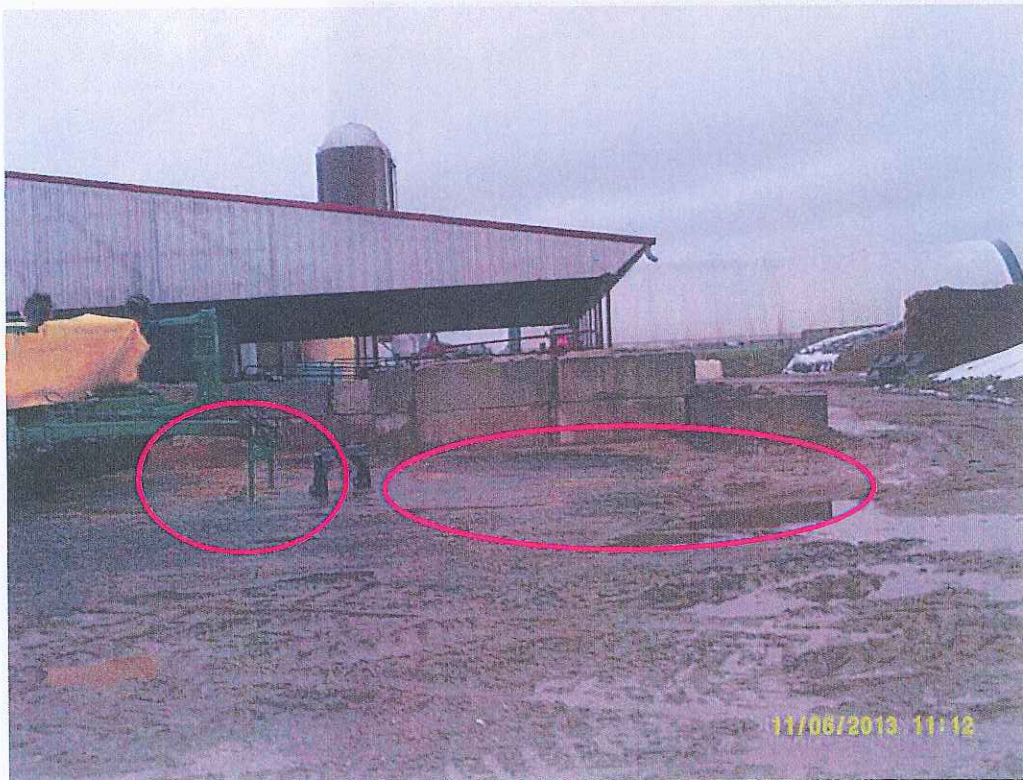
The inspectors continued north and then east to inspect behind Building 3. The inspectors noted surface runoff coming in contact with feed and bedding from Building 3. They also noted the presence of flowing water within the intermittent tributary and the direction of flow.

Photo DSCF0041: Feed and bedding coming into contact with surface runoff.
Date/Time: 11/6/2013 11:12 A.M. Location: West side Building 3. Facing: East

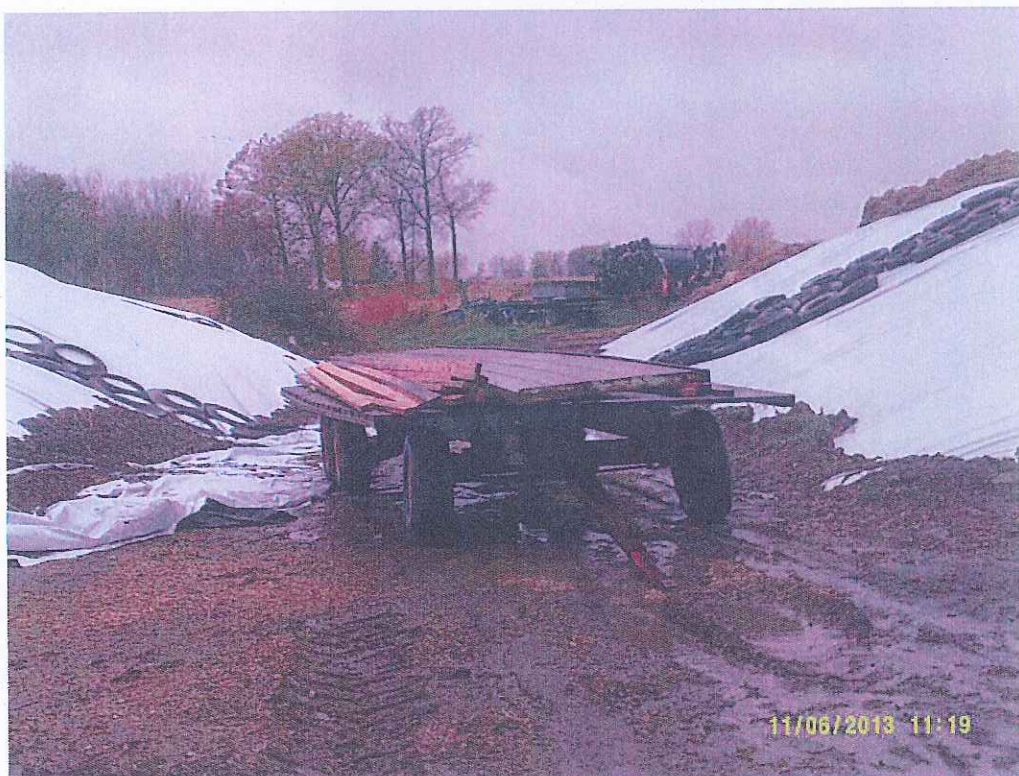
DSCF0050: Surface runoff mixing with loose feed and leachate and flowing between covered feed mounds 2 and 3 to pathway 3.

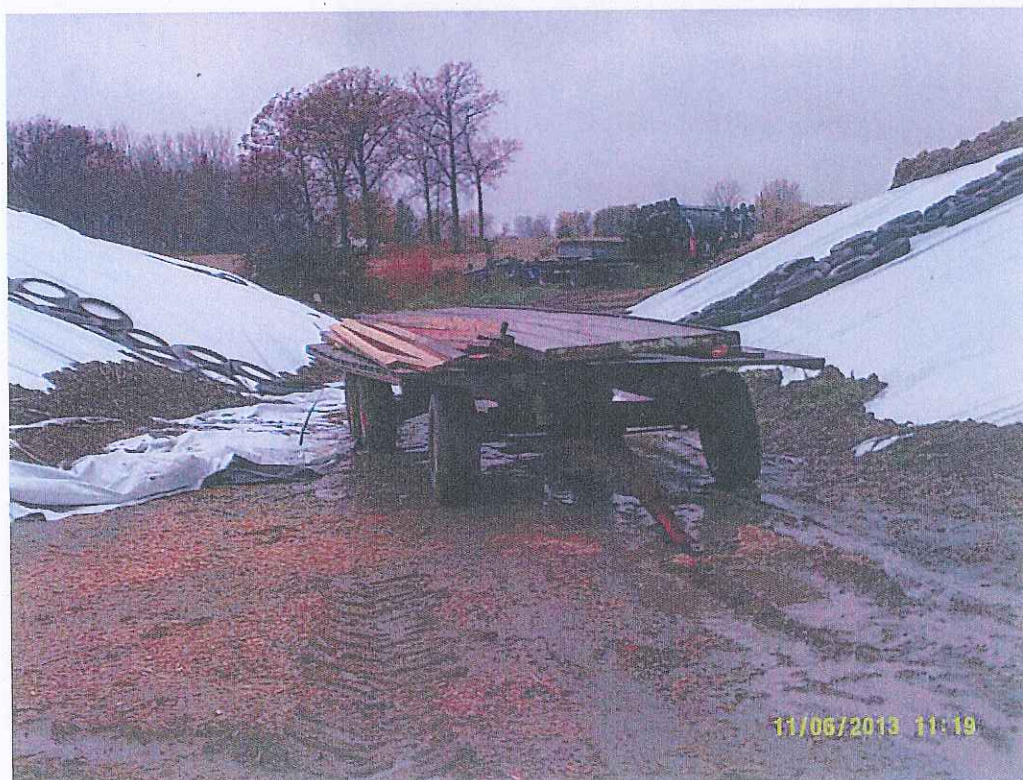
DSCF0051: Surface runoff mixing with loose feed and leachate and flowing between covered feed mounds 2 and 3 to pathway 3.

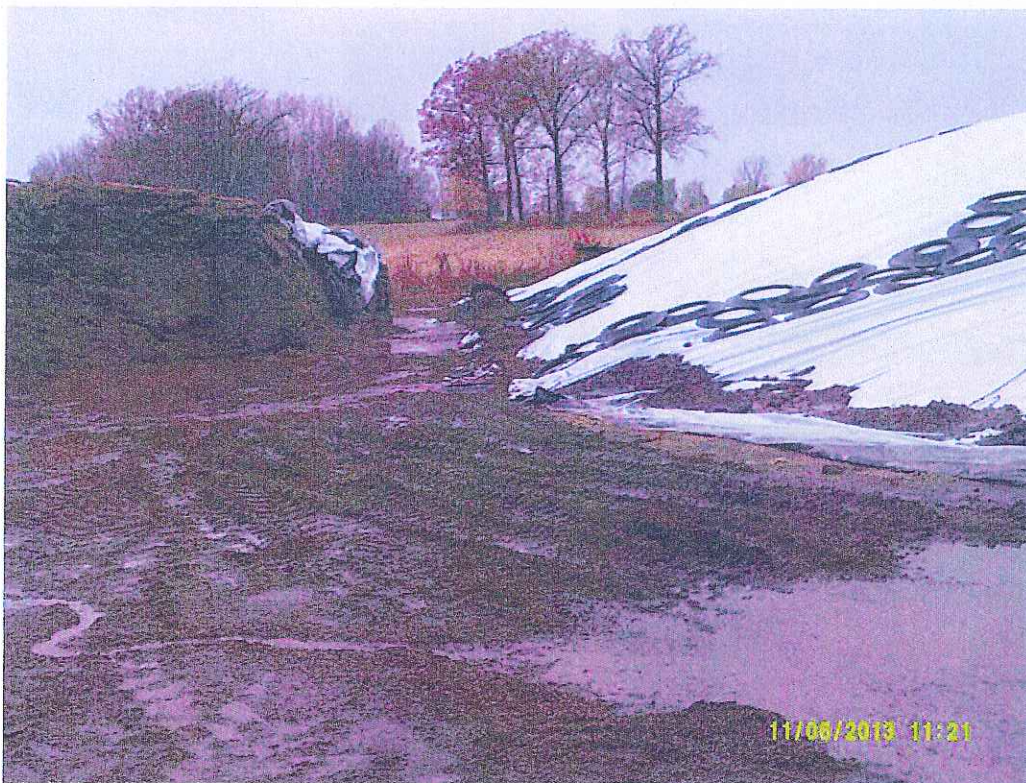
DSCF0052: Surface runoff mixing with loose feed and leachate and flowing between covered feed mounds 1 and 2 to pathway 2.

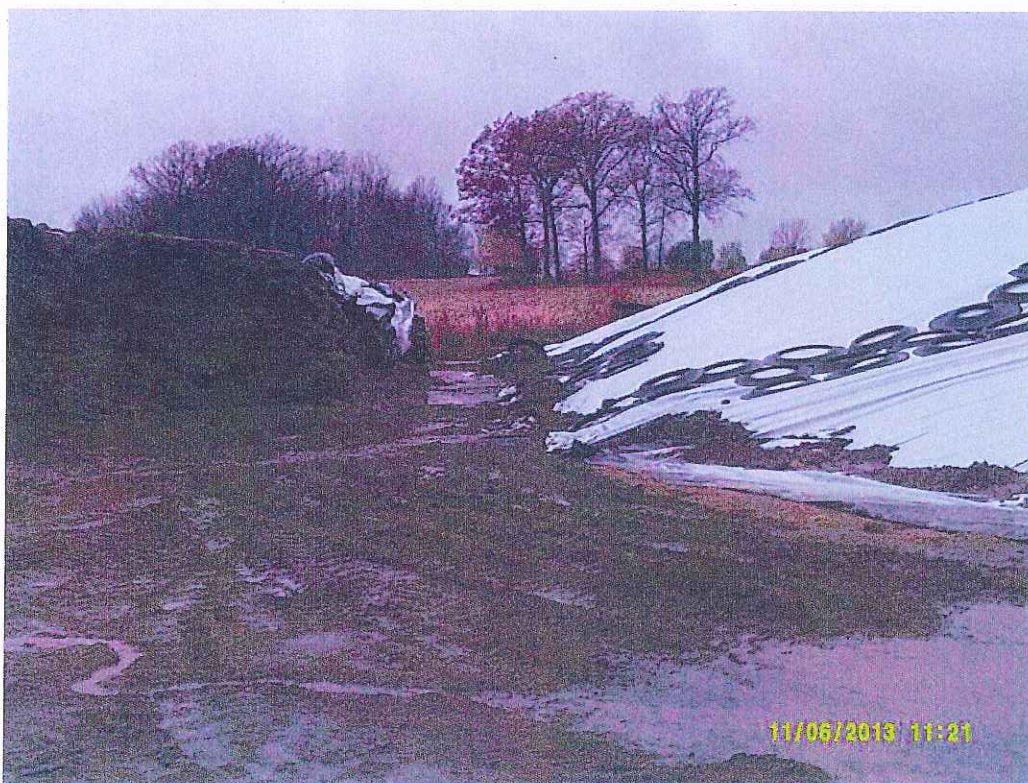
DSCF0053: Surface runoff mixing with loose feed and leachate and flowing between covered feed mounds 1 and 2 to pathway 2.

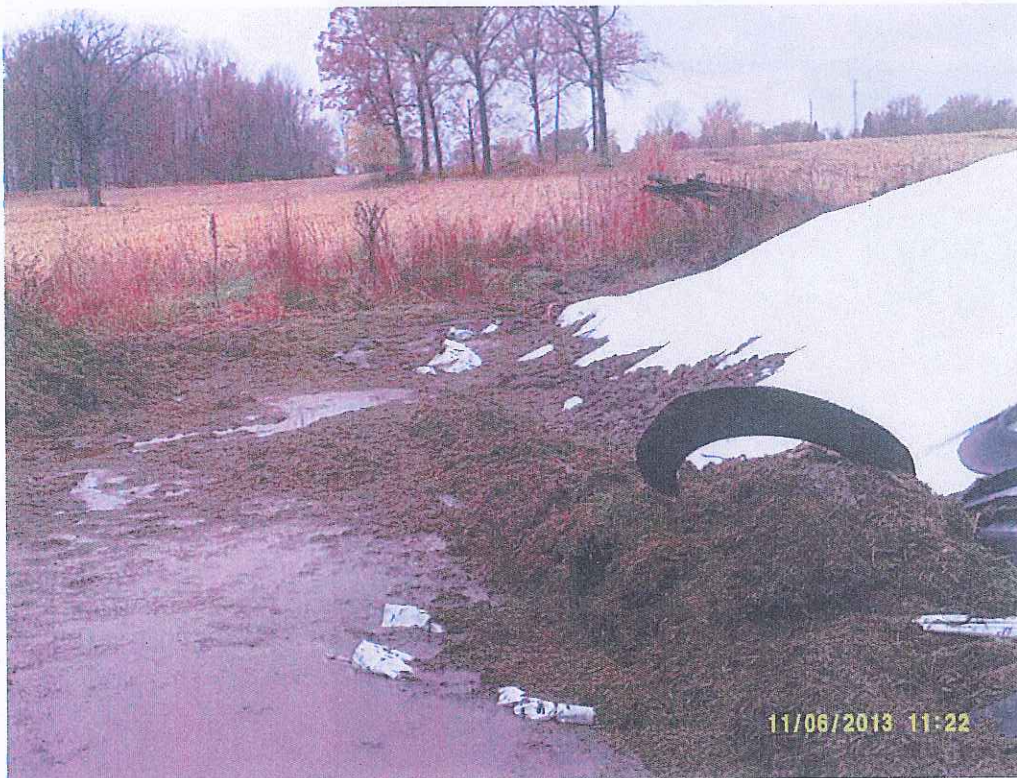
Photo DSCF0054: Surface runoff mixing with loose feed and leachate and flowing between covered feed mounds 1 and 2 to pathway 2.
